# Sikkim Earthquake 2011 – A Roadmap for Resurrection

REPORT  
Submitted to  
The Ministry of Home Affairs, Govt. of India

**NATIONAL INSTITUTE OF DISASTER MANAGEMENT**  
Ministry of Home affairs, Govt. of India, New Delhi

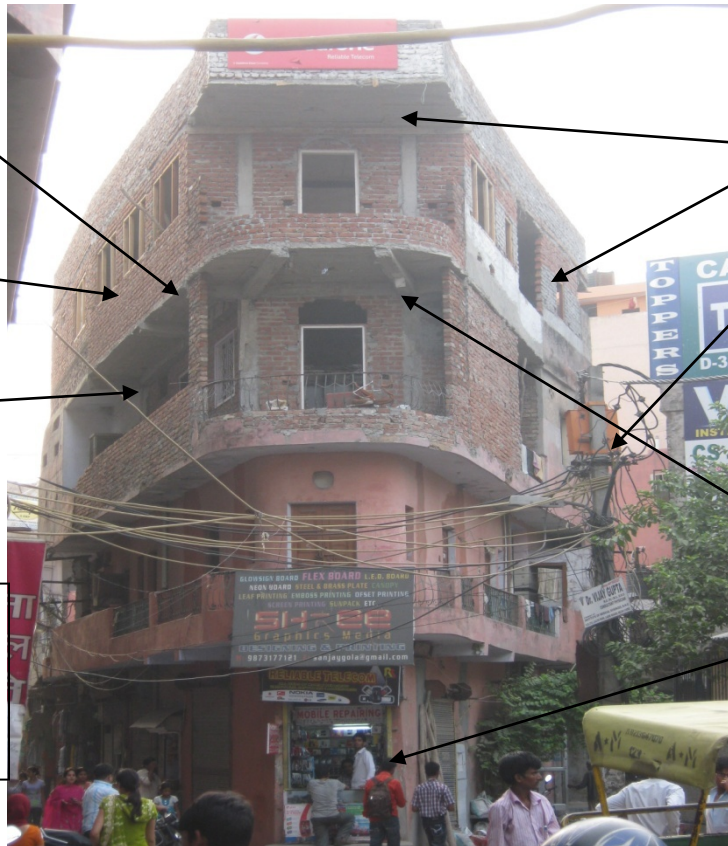
Such buildings are highly vulnerable and no plausible remedial /strengthening measures would be sufficient enough to cater earthquake of M6 or MSK- VII

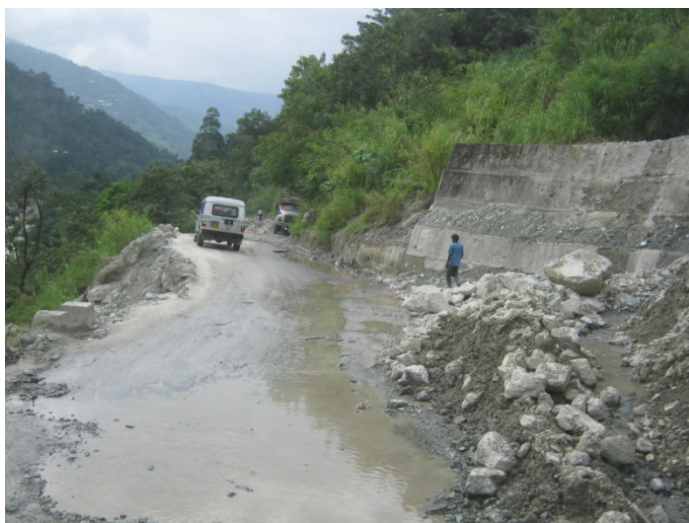
**Fig. c-1** Road conditions became worse due to landslides and drains got choked

**Fig. c-2.** Buildings in capital city Gangtok are standing on steep slope with little or no measures for foundation protection. Almost same is the situation in all hilly states of India, mostly in seismic zone –V. They are laid one adjacent to others with no spaces in between for free vibration during earthquake shaking.

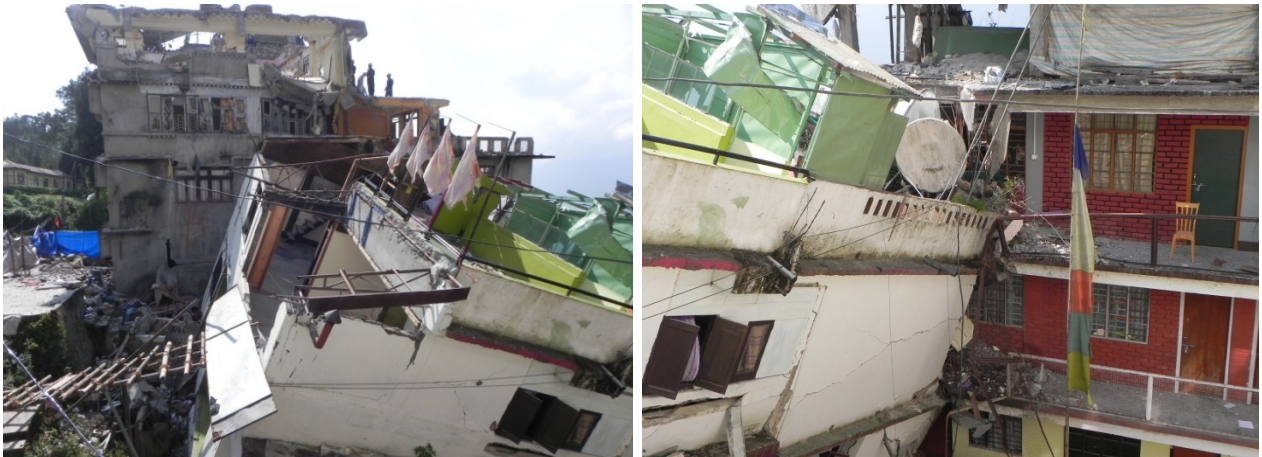
**Fig. d-1.** Two buildings at Baluakhani developed excessive tilt on 23<sup>rd</sup> Sept 2011. Special team from Hyderabad were engaged for demolition. Several buildings in Gangtok have been declared unfit and they are being demolished one by one. However, it important to look into the safety of these buildings by expert team. It would be wise to check if retrofitting is possible by careful planning and supervision of the entire works. Some guidelines for damage survey are given in the appendix.

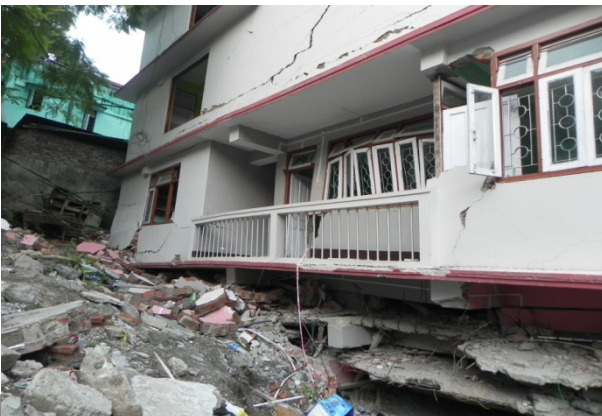
Sikkim collapsed during earthquake. This has to be demolished completely

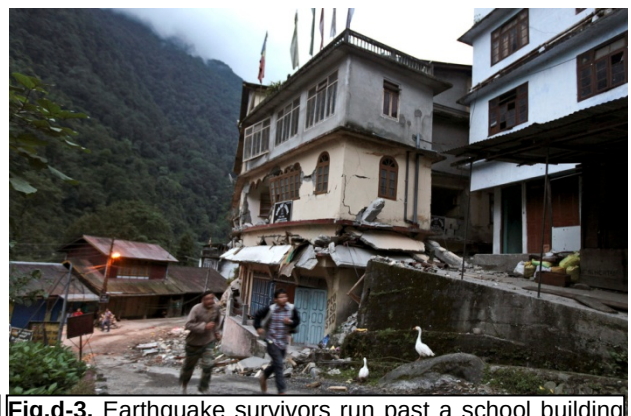
**Fig.d-3.** Earthquake survivors run past a school building damaged in Sunday's 6.9-magnitude earthquake in Chungthang, India, Sept. 21, 2011. AP/ Altaf Qadri

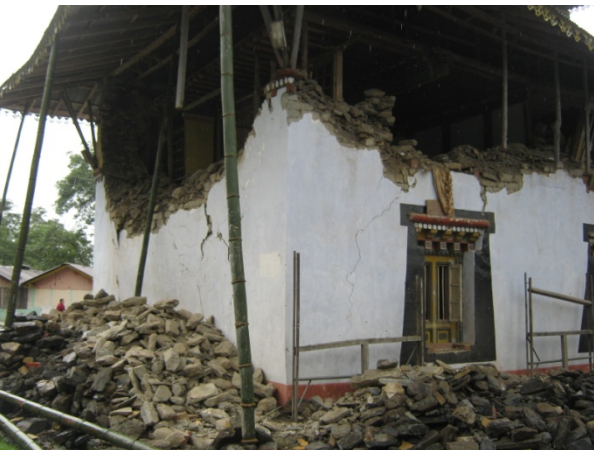
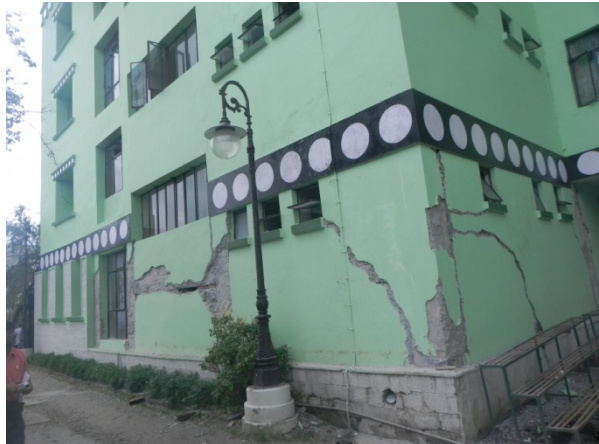
**Fig. d-4..** Ringhim monastery at Mangan, North Dist., and Govt. secretariat at Gangtok suffered huge damage

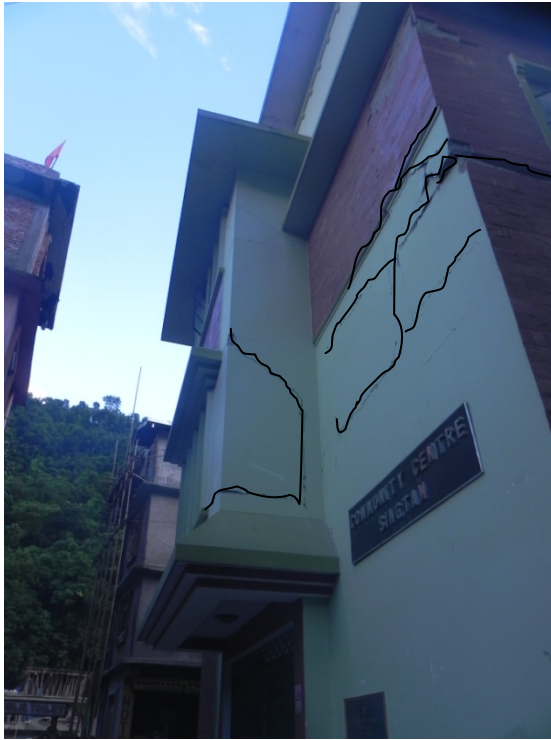
**Fig. e-1.** Cracks in Community Centre, Singtam and many such buildings can be **repaired and retrofitted without much cost and time**. Just deciding to demolish these kinds of buildings without detail structural safety assessment would be rather unwise and costly exercise.

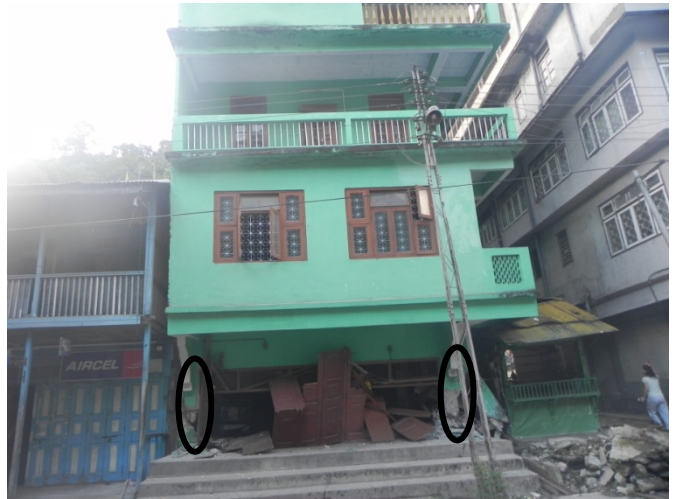
**Fig. e-2..** This pvt. Building at Singtam town lost load bearing power to two of the front columns at ground floor, thus it could be a fit case for demolition. However, it was found that this building suffered very little structural damage to the upper floors. **The amount required for proper retrofitting of the same could be much less** than demolition and thereby fresh construction cost by the owner. The govt. need to devise proper policy for load sharing of reconstruction burden else punitive order to carryout such work by affected owner would be difficult to sustain.

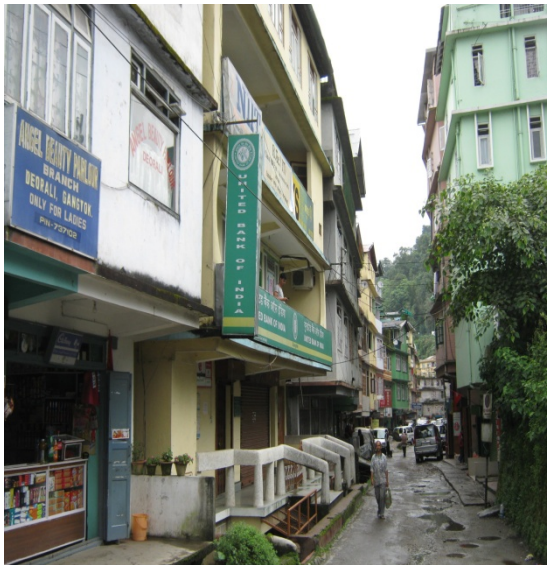
**Fig. e-3.** Fearing from aftershock effect many residents in Deorali area, Gangtok spend nights in this narrow lane vied with tall buildings. Almost all buildings in this area developed cracks in the partition wall.

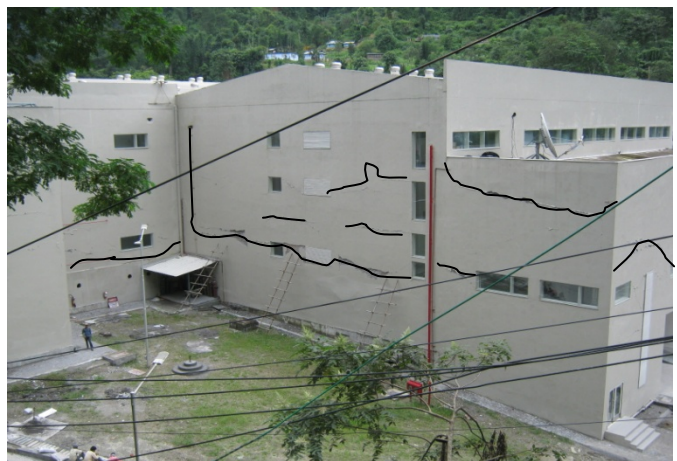
**Fig. e-4.** Torrent Pharmaceutical Industry complex, with more than 500 employees, near Sikkim Supreme Factory, NH31A, suffered severe damage in the walls. Upon inspection of the same it was conveyed that owner shall be taking sufficient measures to restore everything. **It is required to have a check on such commitments by pvt. Industries and hydroelectric project authorities.**

This complex is also vulnerable to landslides along NH31A for which no effective preventive measures found.

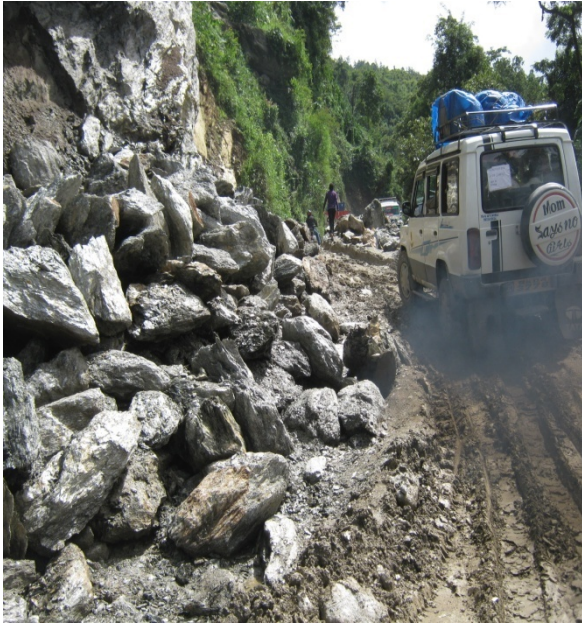
**Fig. g-1.** Road clearance made upto Mangan, North dist. HQ., in 3 days time after the earthquake but long term performance measures not ensured thus affecting work of power projects,

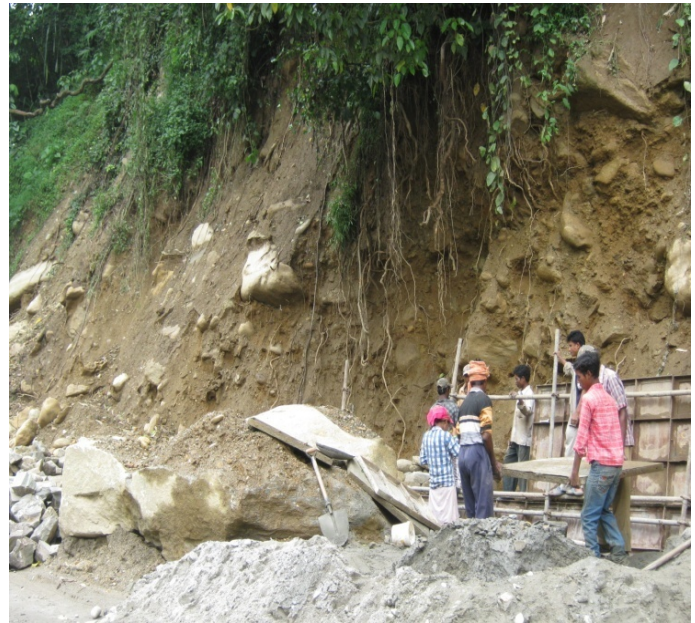
**Fig. g-2.** Road widening along NH31A near Ranipool is on but technical feasibility of taming cut slope as seen here are very much local and pristine

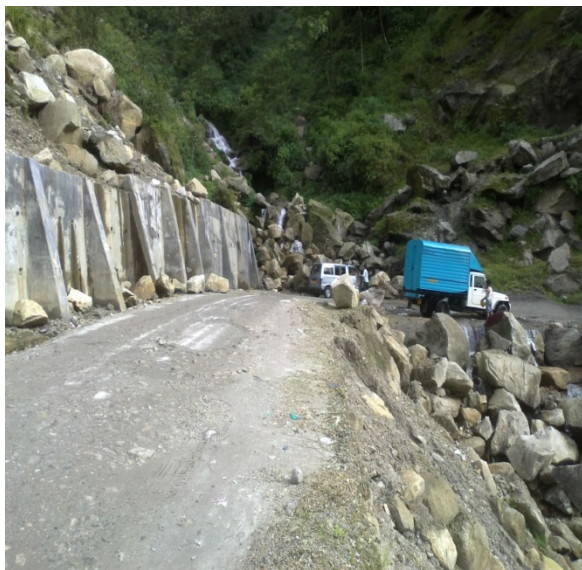
**Fig. g-3.** Controlling measures around the Bagthang water falls, in the form of buttressed retaining walls are no way effective in preventing landslides. The road has no culvert or x-drains. Boulders are constant threat to unwary travellers.

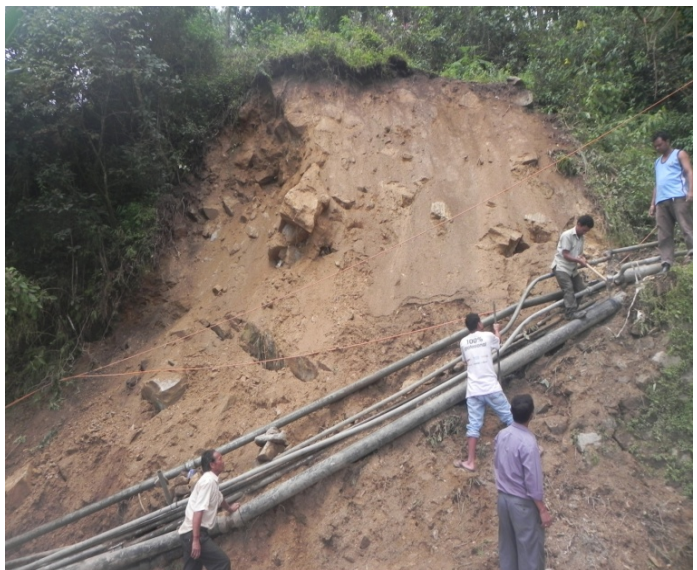
**Fig. g-4.** Landslides caused severe trouble to dwindling infrastructures services and utilities. Once again restoration of the same has hardly any technology in place

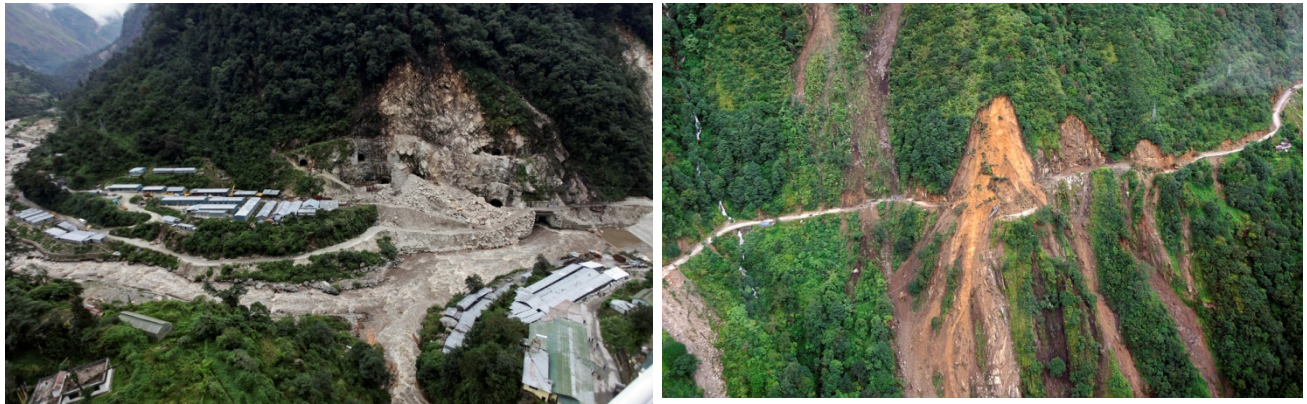
**Fig.h.** An aerial view of Teesta III hydro power project site partially damaged in Sunday's earthquake in Chungthang, India, Wednesday, Sept. 21, 2011 and aerial view of massive landslides triggered by the earthquake along Gangtok-Mangan highway. (source AP / Altaf Qadri)

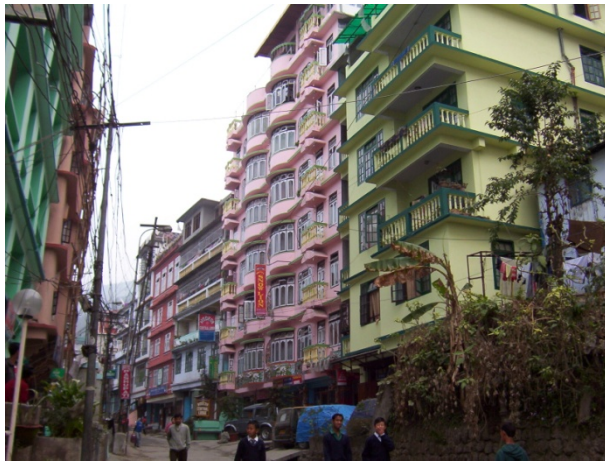
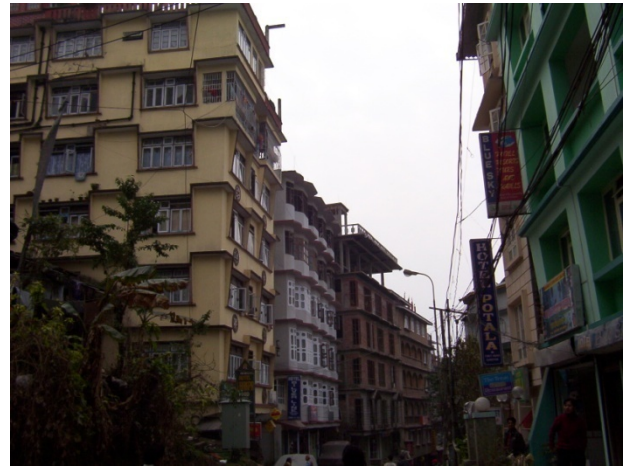
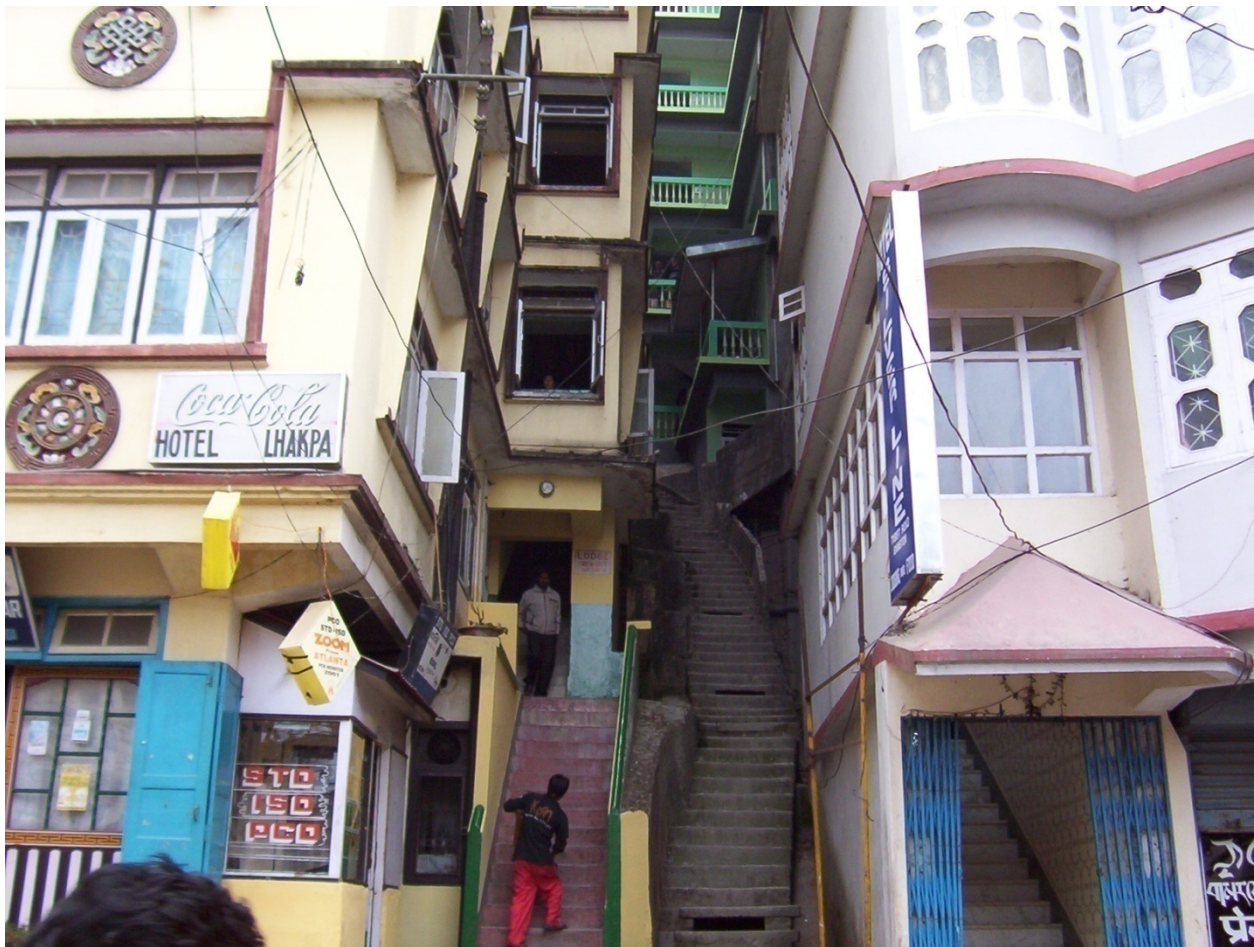
Figure 2 Buildings in Gangtok are standing as high as 8 floors on steep slopes with little or no spaces in between and having all vulnerable components such as floating walls, soft storey, irregular geometry in plan and elevation, etc. Though most of all, as shown above, are having defined load bearing members such as beams and columns, their integrity are subject to performance criteria defined by each visiting earthquake in the region.

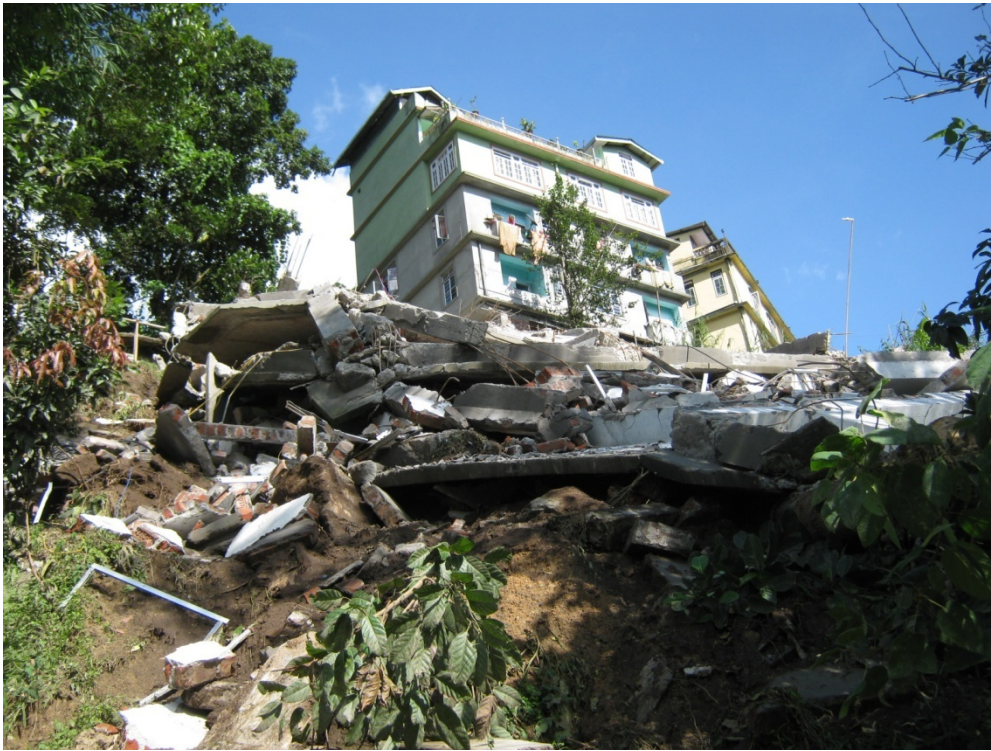
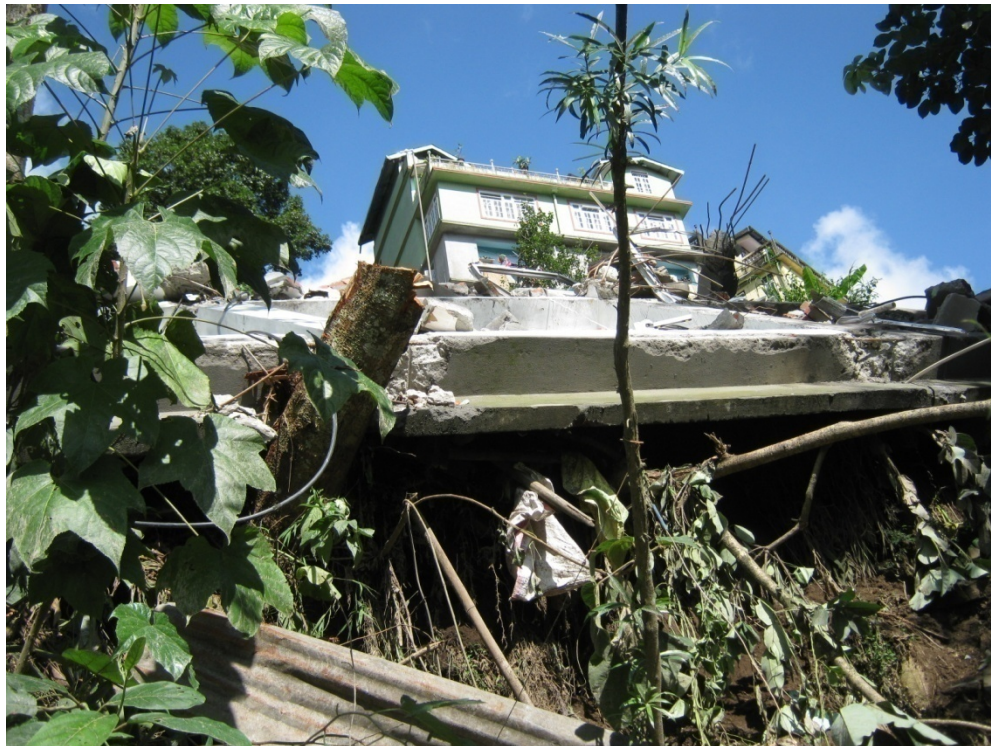
Figure 11 One 3 storey newly constructed building near Lumsey primary school, Gangtok collapsed during earthquake. Reason for failure not known yet. Approach road for demolition equipments are not available. Debris are precariously retained till date by few trees, main trunk of which were cut by electric power department

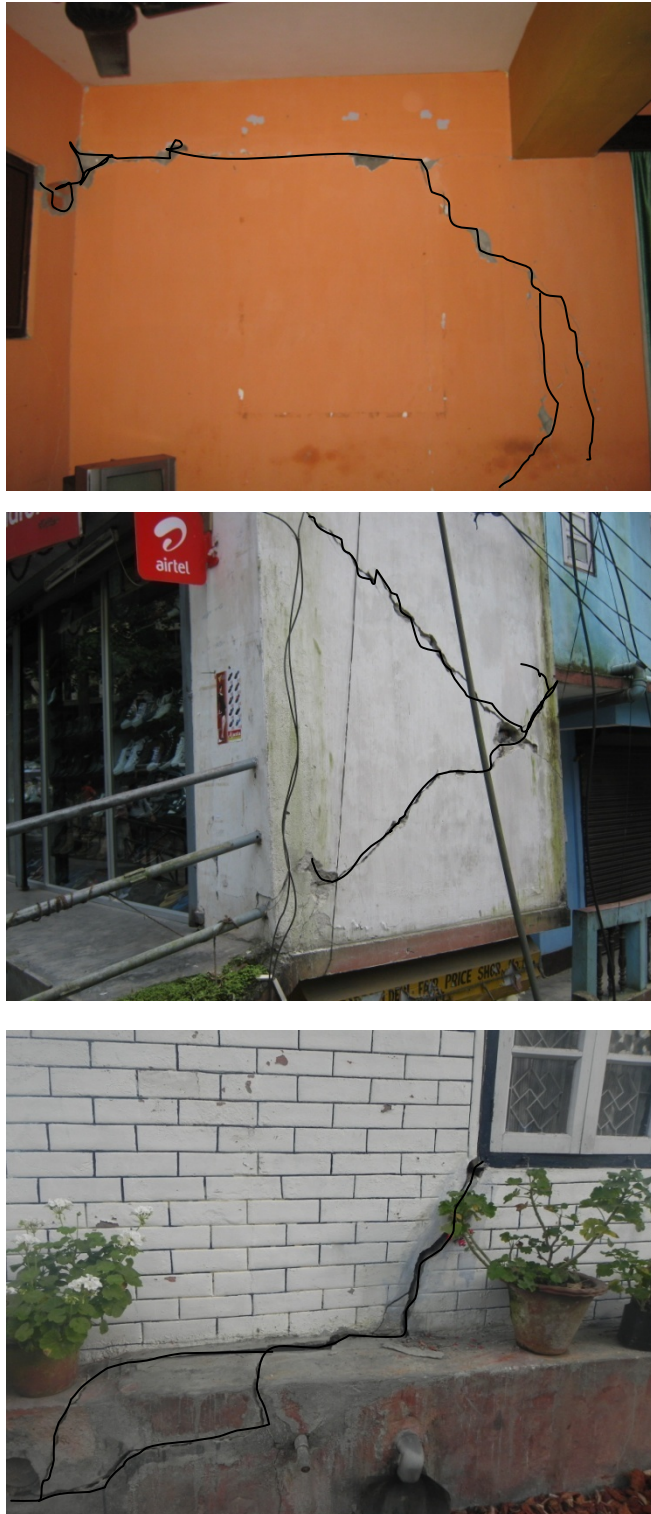
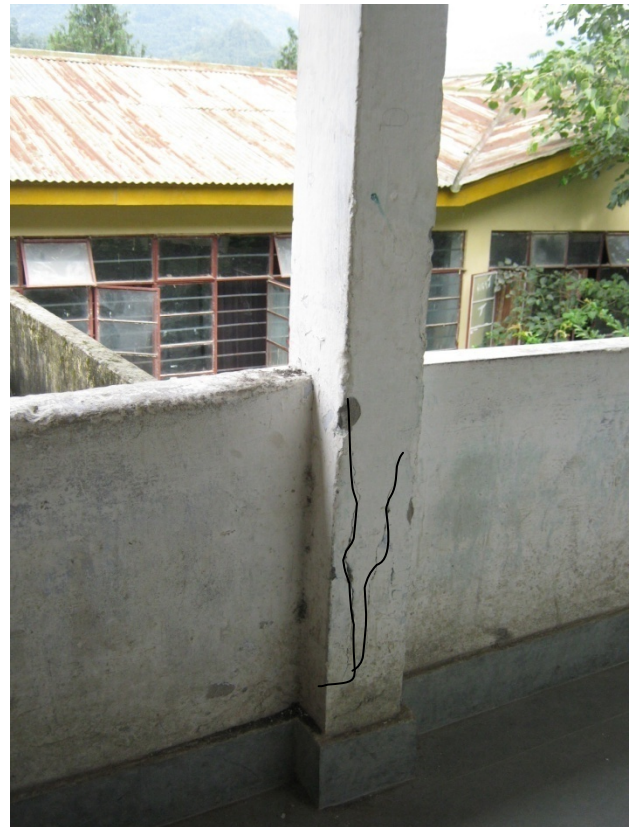
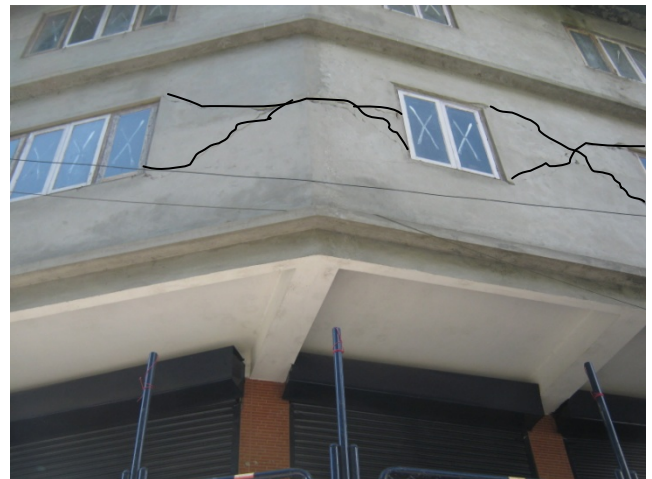
Figure 16 Damages in buildings in and around Gangtok. These cracks are entirely repairable but cannot be assured for enduring moderate shock again

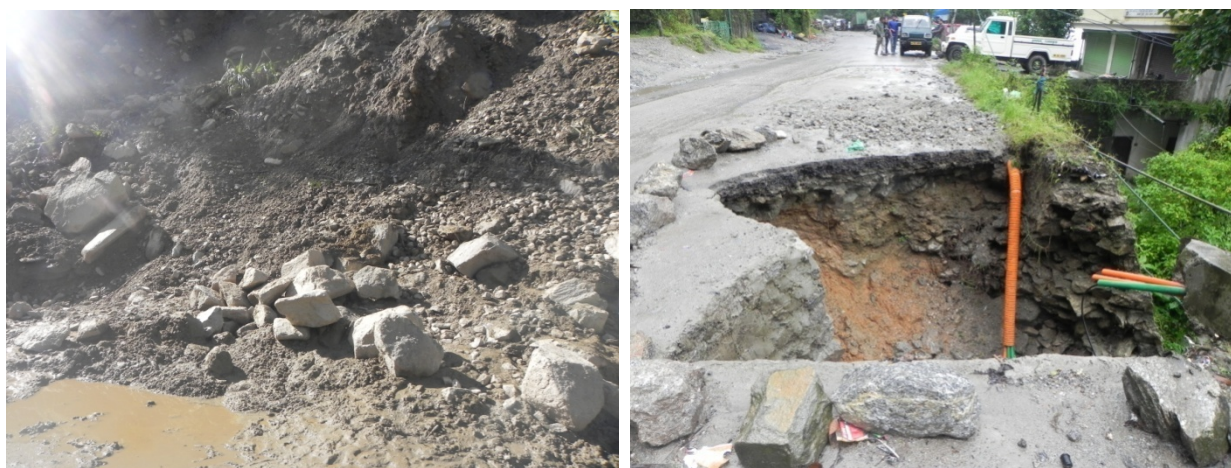
Figure 17 Landslides along NH31A. earthquake has triggered several landslides along national highways. The fragility of roads in the hilly area has been exposed by this earthquake, which otherwise too vulnerable to season rain fall. Road widening works in many roads has made them more vulnerable than before. BRO has been active in removing debris but not yet so effective on the promulgation of new technologies. Clearing roads just for allowing one way traffic for the time being is not enough to continue with the ongoing power house construction project. Teesta stage III project is now on halt due to labour shortage. They fled after the earthquake.
