# **TOWARDS REBUILDING A NEW ANDAMAN & NICOBAR SHELTER & HABITAT REHABILITATION**

**GoI - UNDP Disaster Risk Management Programme**

**MINISTRY OF HOME AFFAIRS**

**M a r c h 2 0 0 5**

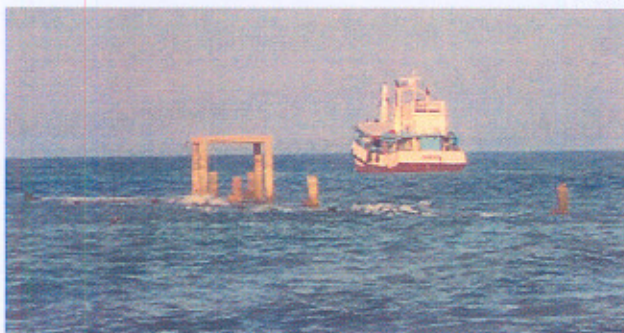
*Bengali Jetty damaged and submerged under sea water at Teressa*

Twenty-one out of the forty nine jetties in the islands were severely damaged. The passenger hall at Port Blair Haddo No. 3 jetty was completely damaged. The end portion of the Fisheries jetty sunk. In Hut Bay, the jetty was totally damaged and the approach to the breakwater and wharf was also damaged.

In Car Nicobar the approach to the Mus wharf was partly damaged while the Malacca Jetty was totally damaged. In Campbell Bay the approach to the jetty collapsed completely. The jetties at Chowra, Teresa, and Katchal were severely damaged. Cracks developed in jetties at Kamorta and Nancowry.

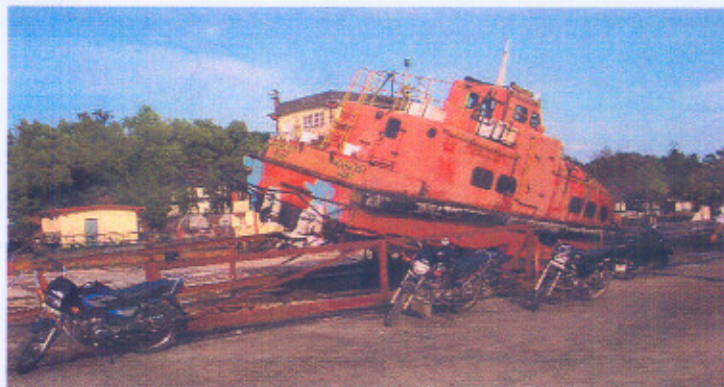
*Vessel brought inland by tsunami waves at Port Blair*

Seven shipping vessels were damaged and two vessels sunk in the five sweeps of tidal waves. Propellers, Hulls, Shaft, Superstructure etc., were damaged in the above vessels. Both the dry docks were damaged and lock gates (caissons) were beyond repair. A forty ton diesel storage tank were uprooted and damaged with fuel partially leaking in the sea.

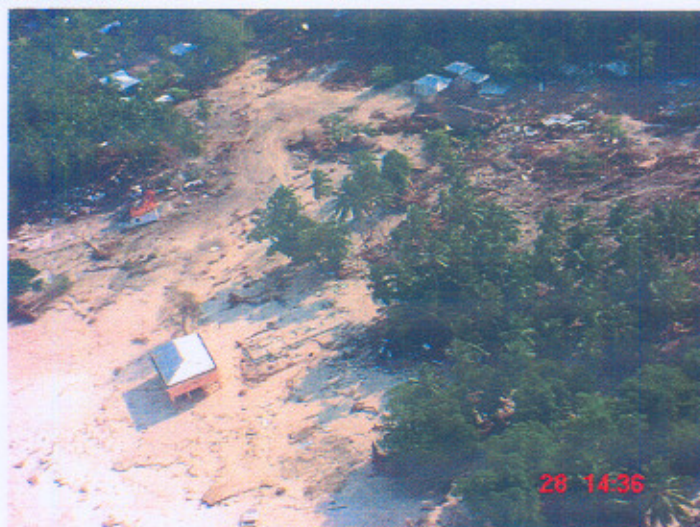
*An aerial photograph of the damages caused to houses by tsunami*
