# Sikkim Earthquake 2011 – A Roadmap for Resurrection

REPORT  
Submitted to  
The Ministry of Home Affairs, Govt. of India

**NATIONAL INSTITUTE OF DISASTER MANAGEMENT**  
Ministry of Home affairs, Govt. of India, New Delhi

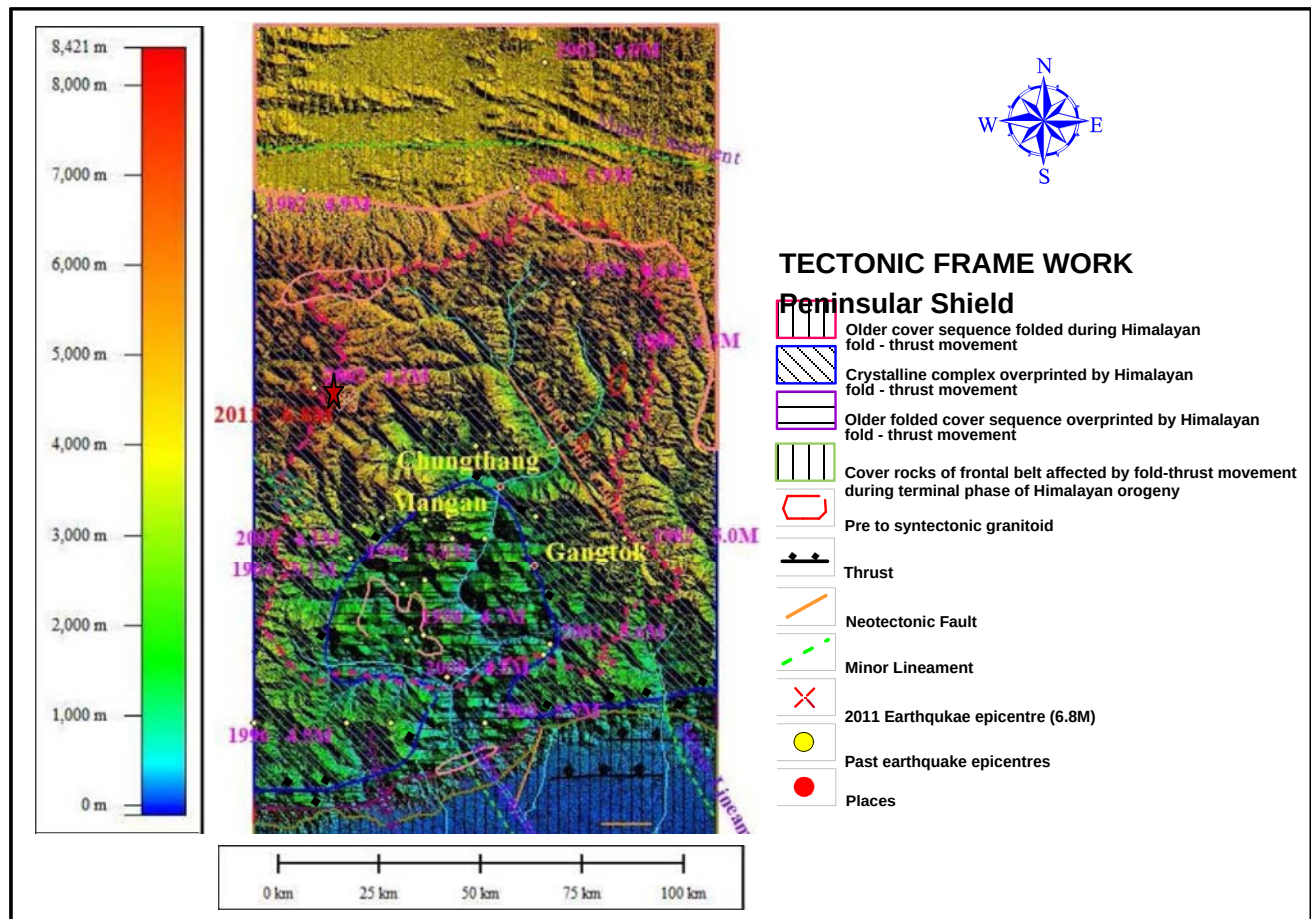
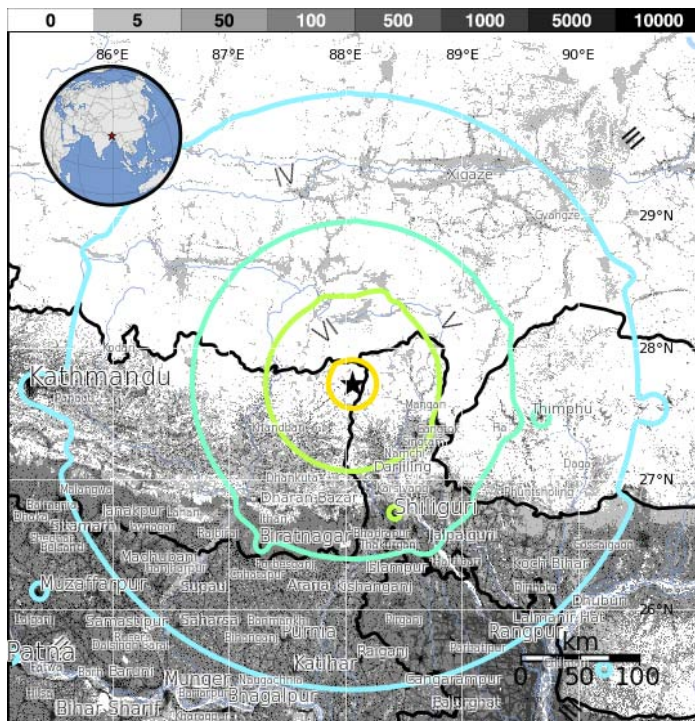
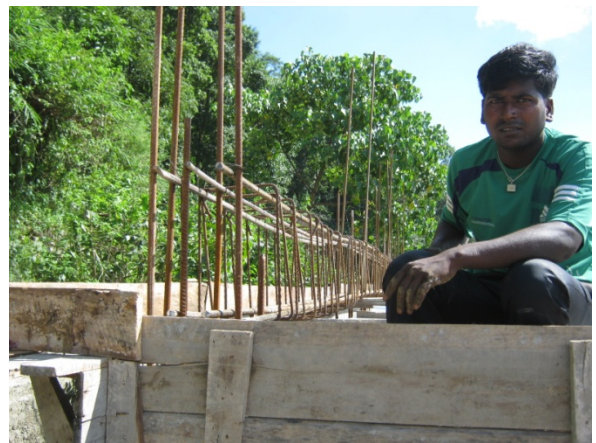
**M6.8 earthquake on September 18, 2011** shook the NE states including neighboring countries Nepal, Tibet, Bhutan and Bangladesh, killing 77 in India, damaging infrastructures and development prospects. Sikkim is in seismic zone – IV and has the potential to face MSK VIII intensity earthquake. Despite having details of seismic microzonation in 2006, well developed seismic code and National Building Code-2005, the end result is still unchecked construction as seen above, are rampant in the entire country

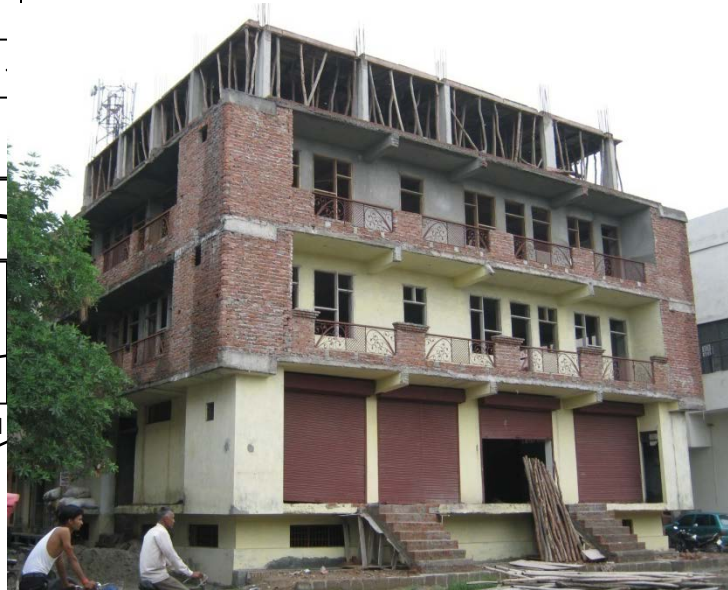
**Fig. a. VULNERABLE COMPONENTS OF A  
TYPICAL BUILDING IN SEISMIC ZONE IV**

Large opening and windows

Floating wall at corner

Extension of upper floor with improper shuttering

Long verandah with parapet – nonstructural damage

Adjacent to electric poles – health hazard

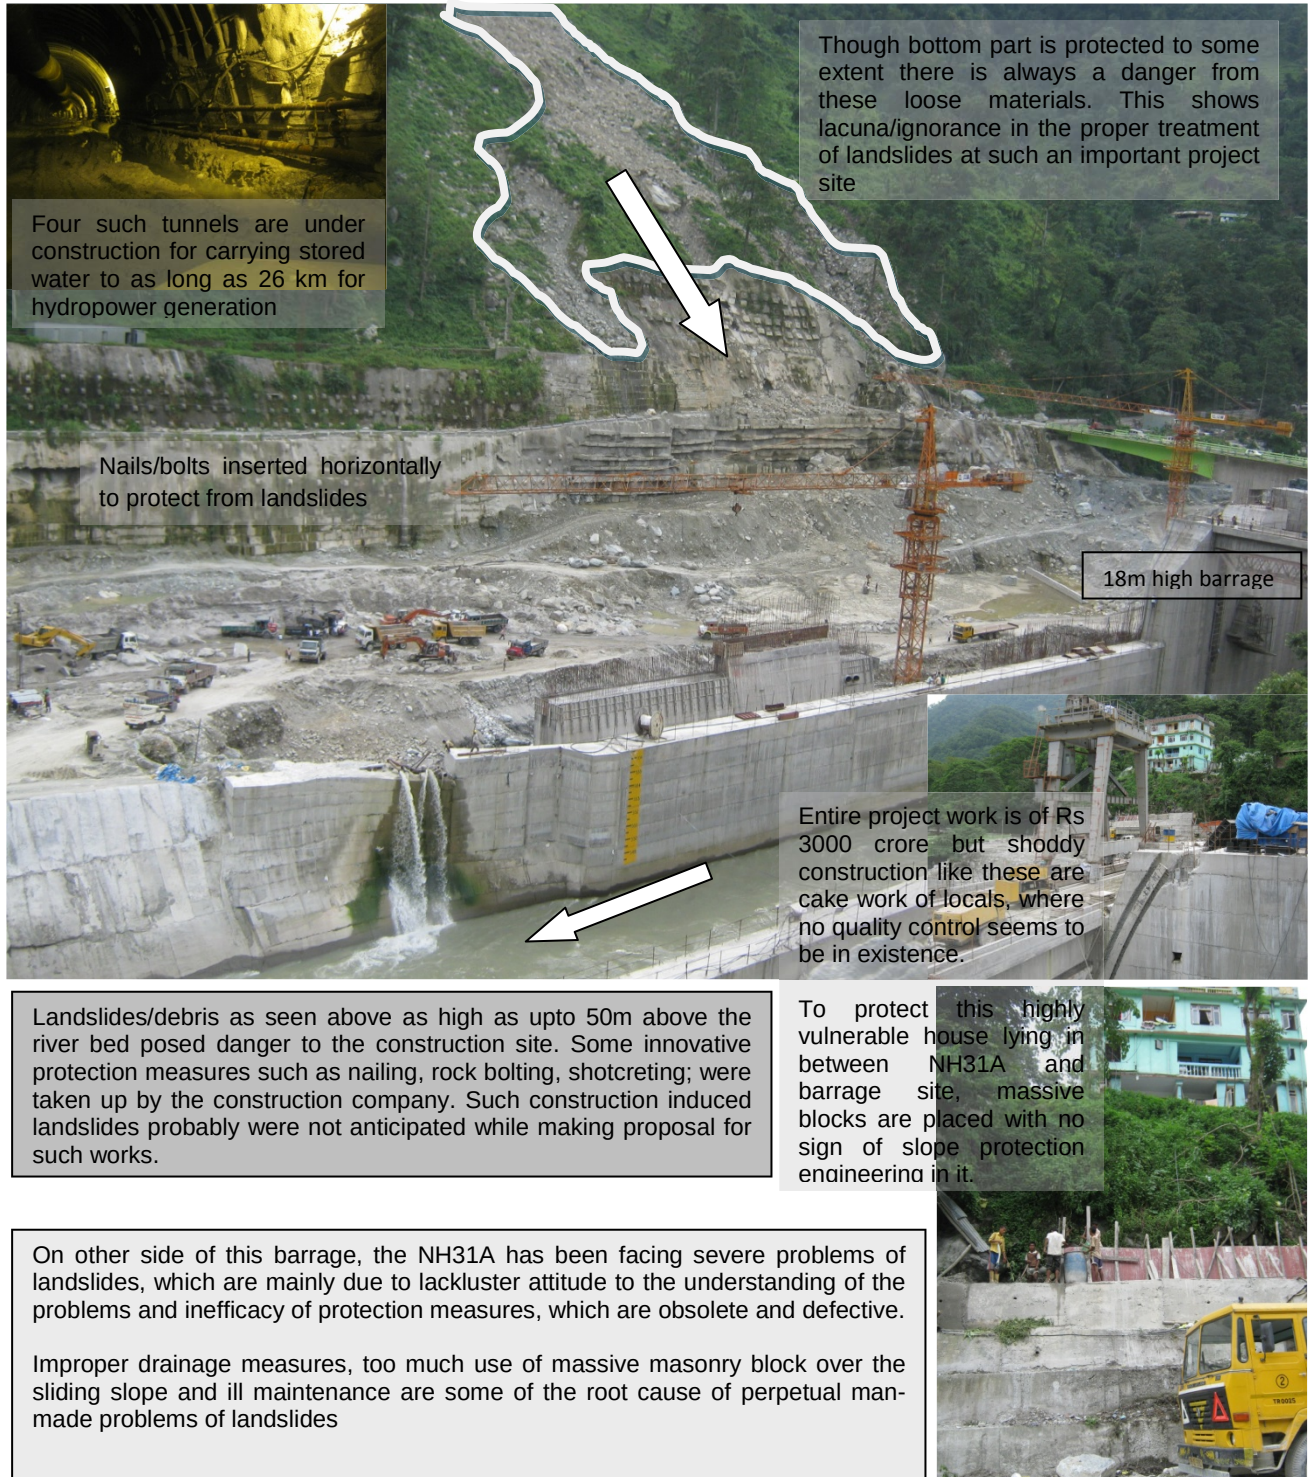
Fig. b. Ongoing Barrage construction site at Sirwani, near Singtam, Sikkim state, along with 26km tunnel for hydropower generation by Lanco Infratech Limited

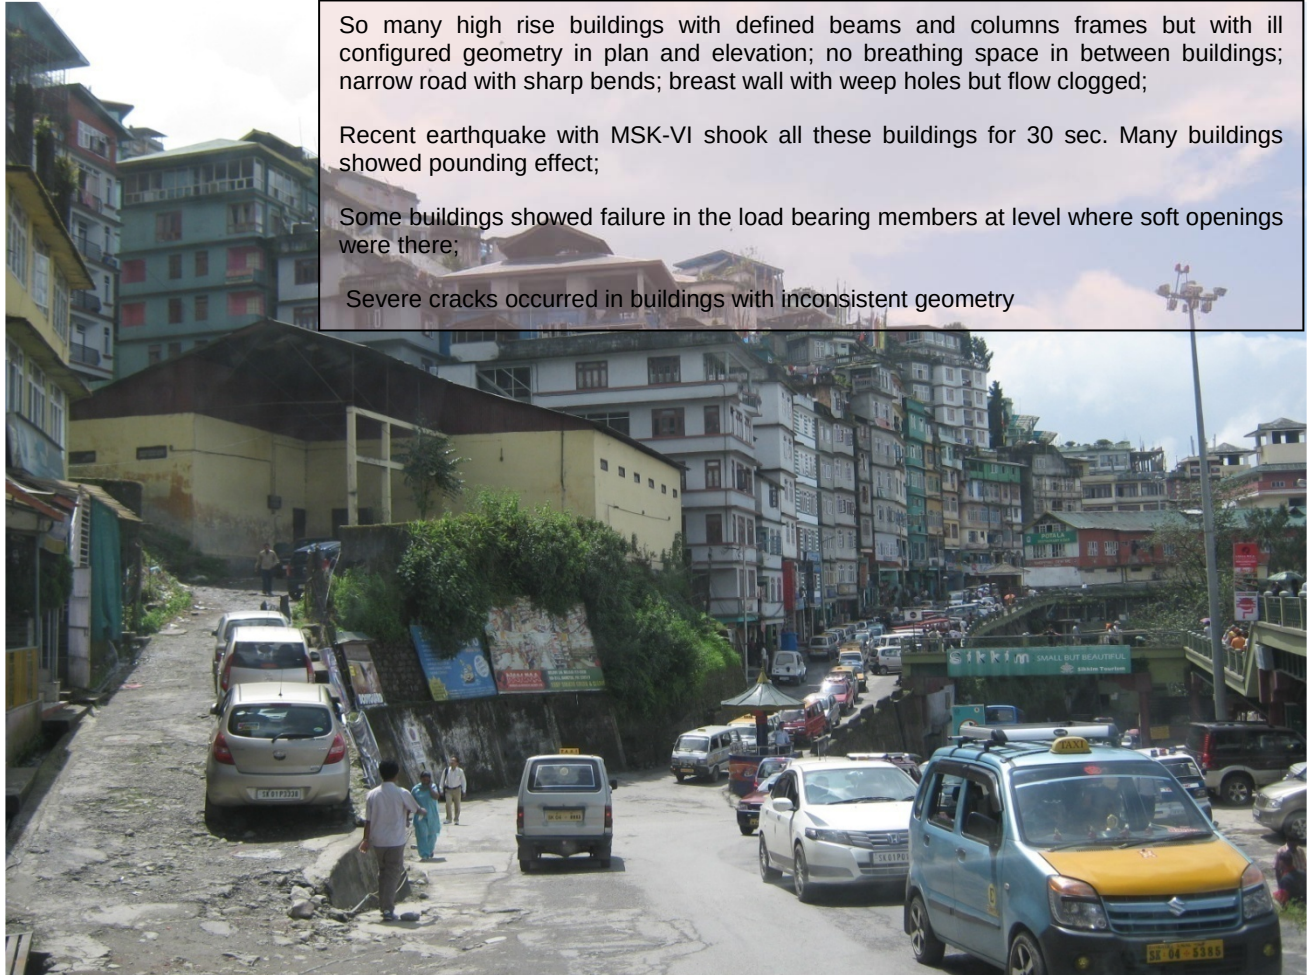
So many high rise buildings with defined beams and columns frames but with ill configured geometry in plan and elevation; no breathing space in between buildings; narrow road with sharp bends; breast wall with weep holes but flow clogged;

Recent earthquake with MSK-VI shook all these buildings for 30 sec. Many buildings showed pounding effect;

Some buildings showed failure in the load bearing members at level where soft openings were there;

Severe cracks occurred in buildings with inconsistent geometry

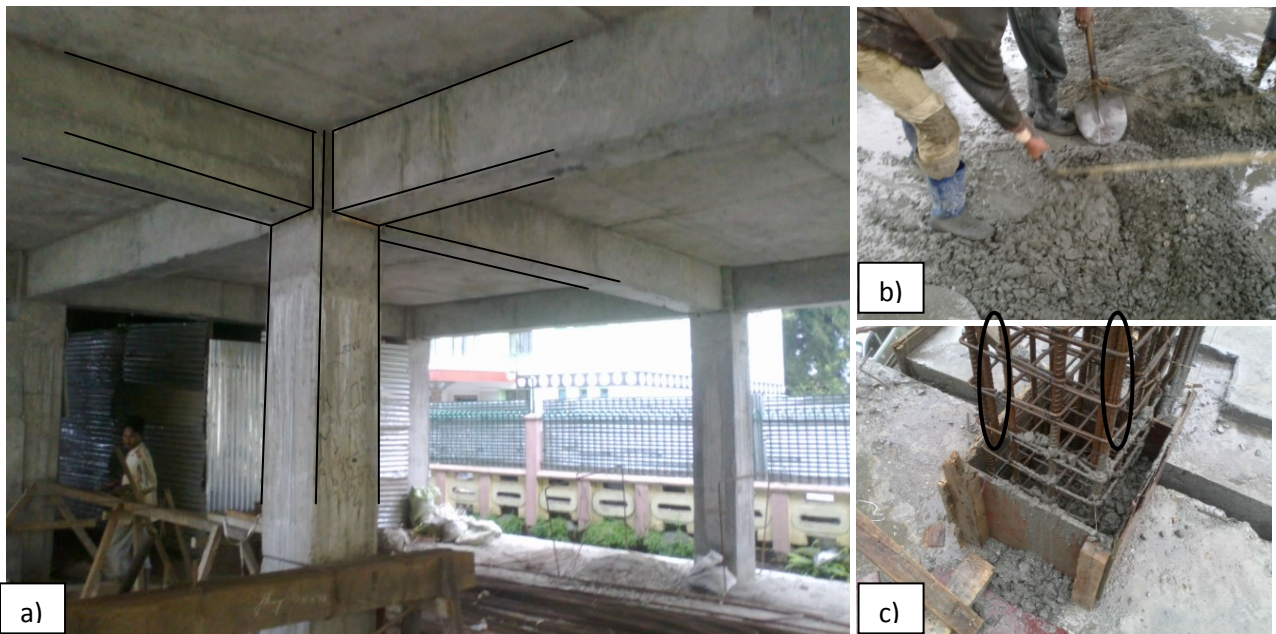
**Fig. i.** This above multi-storey building is under construction for more than a year with combined footing for columns, which are placed in regular spacing. Designer must have taken all measures in providing extra amount of steel reinforcement with multiple shear stirrup yet with  $90^\circ$  lapping. There seems to be no compromise on the quality of building materials but concrete in (b) and lapping type seen in (c) in the 4<sup>th</sup> floor might have not been revealed in the recent earthquake.
